Country Name	Project for Operation and Maintenance of Trunk Road: Goha Tshion-Dejen across Abay Gorge (Equipment Supply)
Federal Democratic Republic of Ethiopia (FDRE)

I. Project Outline

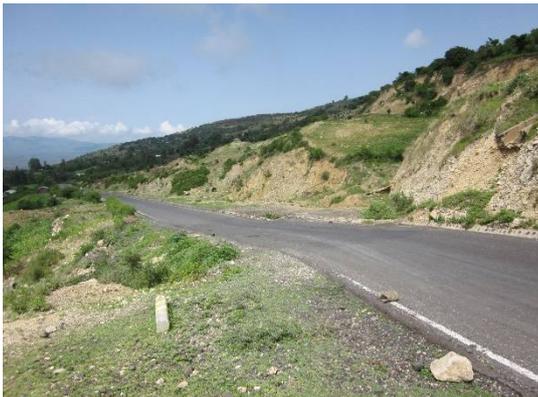
(Rehabilitated road in Abay Gorge)

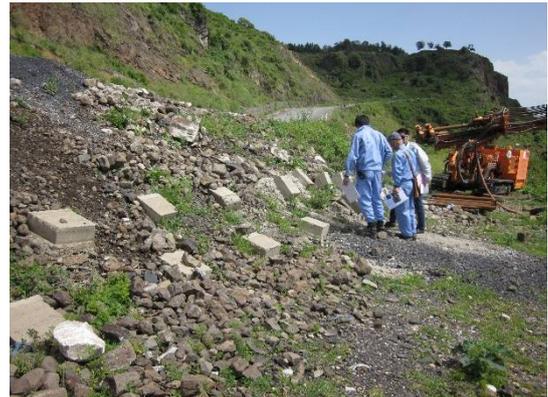
(Machinery (Horizontal Boring) in operation)

Other positive impacts include first, decrease of landslides. The procured equipment has been used also for landslide prevention works, such as safety barriers against rock fall and horizontal boring. There were six landslide vulnerable stations between Goha Tshion and Dejen, but currently the problems at four stations were completely solved (there have been no landslides). Second, the nearby residents can reach the urban areas for agricultural markets and health centers much faster than before and students can commute without fear of road blockage.
