Islamic Republic of Pakistan

FY2015 Ex-Post Evaluation of Japanese Grant Aid Project

“Urgent Rehabilitation Project for Sewerage and Drainage System in Lahore”

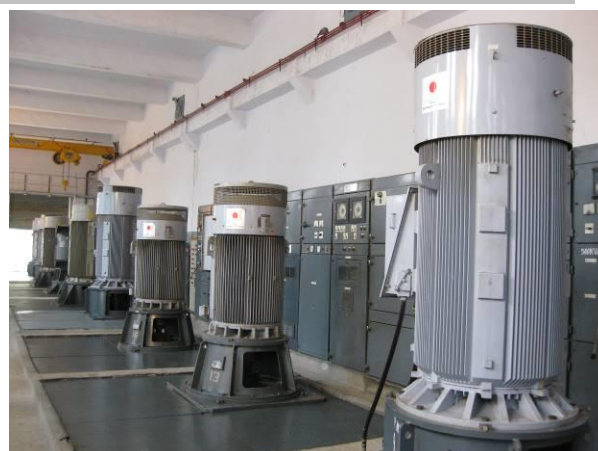
Operation and Electric Room
(Gulshan-E-Ravi Pumping Station)

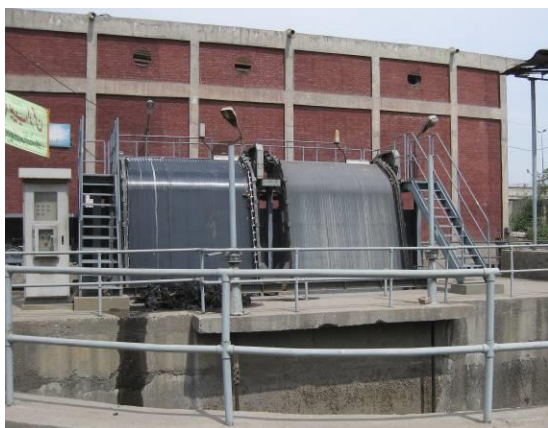
Automatic Trash Rake System
(Shad Bagh Pumping Station)

Qualitative effects were examined from the perspectives of mitigating the pumps' deterioration and easing the workload of the cleaning staff – referred to as “sanitary workers” – in the pumping station where the automatic trash rake systems were installed. Interviews with the WASA staff in the Implementing Agency's headquarters and on-site in the Shad Bagh Pumping Station revealed that the following pump operation effects were generated by the introduction of the automatic trash rake systems.

Therefore, the introduction of the automatic trash rake systems is judged to have mitigated the halt and breakdown of not only the pumps provided by this project, but all of the pumps in the Shad Bagh Pumping Station, and also increased the efficiency of the entire pumping station's operation. Improvement in the workload and hygienic conditions for sanitary workers has also been observed.

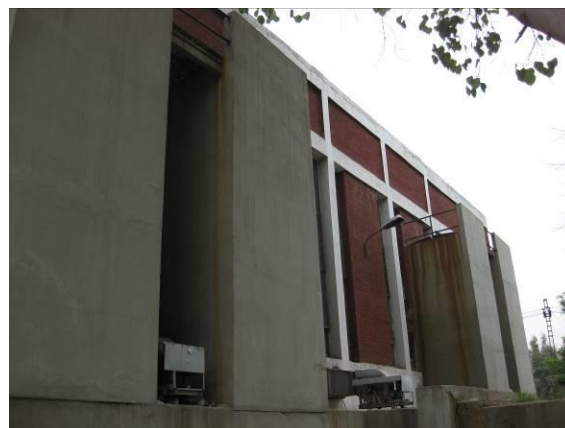
Drainage Basins
(Multan Road Pumping Station)

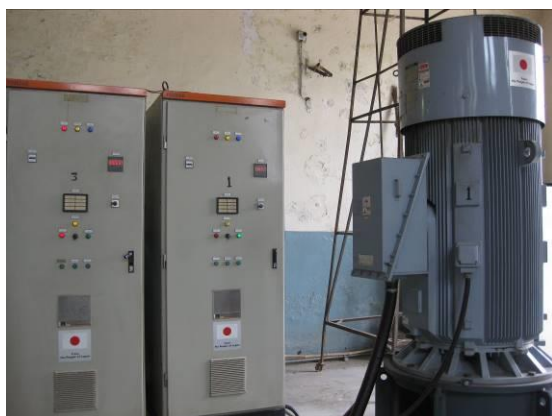
Motor and Electrical Control Panels
(Multan Road Pumping Station)

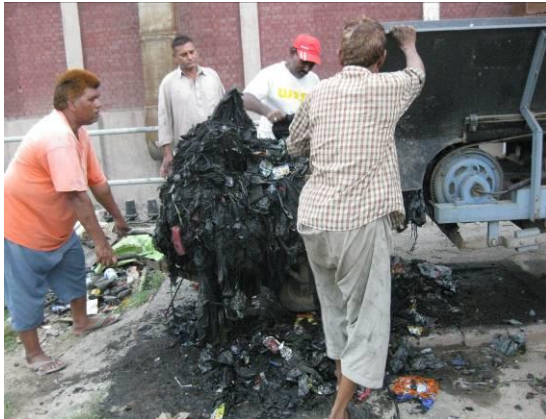
with the design or capability of the automatic trash rake systems installed through the project. The systems' current decline in operational efficiency is regarded as being within the normal range, although they do require constant maintenance in an appropriate manner. To ensure continuation of effective use of the systems taking a great deal of strain even more attention needs to be focused on their maintenance in the future. Currently, however, relevant measures are being taken, such as the preventative maintenance in advance of the monsoon season.

Sanitary Workers Removing Solid Waste from Automatic Trash Rake System

As part of the project, automatic trash rake systems were introduced together with the drainage pumps to mitigate the decrease in operational efficiency of the pumps caused by massive in-flows of solid waste. While the operational efficiency of the pumps has undoubtedly improved because of the automatic trash rake systems, it is observed that these systems themselves have to withstand extensive strain due to constant in-flows of a large amount of solid waste. Although the system's current operation condition is regarded as being within the normal range, it is desirable to start implementing measures to reduce the amount of solid waste flowing into the pumping stations as early as possible, with a view to ensuring their sustained effectiveness in the longer-term. Thus, in planning a cooperation project including the provision of equipment, if certain post-completion supporting activities from the beneficiary country are expected to greatly influence the sustainability of the equipment's effective operation, JICA should encourage the beneficiary country in advance to actively implement the relevant measures. It may be appropriate to first check whether the beneficiary country or the implementing agency's medium term activity plans include such necessary measures.

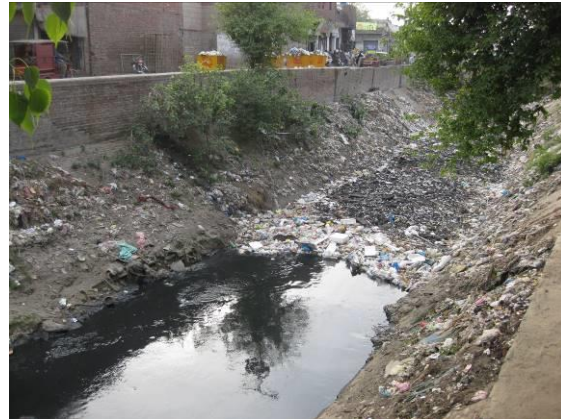
Open Drainage Canal Connecting to the Shad Bagh Pumping Station

A tremendous amount of solid waste still flows into the Shad Bagh and Khokhar Road Pumping Stations directly from the open drain canals stretching in the east side of the stations; moreover, it was revealed during the course of this evaluation that there has been no sign of any decrease of the amount since the project was completed. If the amount of solid waste flowing into the stations exceeds the capacity of the automatic trash rake systems, it may cause severe damage to the pumps, thereby affecting the inundation situation of the people in the entire catchment area of the pumping stations. Therefore, it is recommended that WASA should strengthen its campaigning activities, targeting particular areas to promote people's awareness and behavioral changes in collaboration with relevant authorities and organizations. To prioritize the areas or sections to be addressed, it would be useful to first conduct a survey
