Country Name	The Project for Rural Water Supply and Sanitation in Kano State
The Federal Republic of Nigeria

I. Project Outline

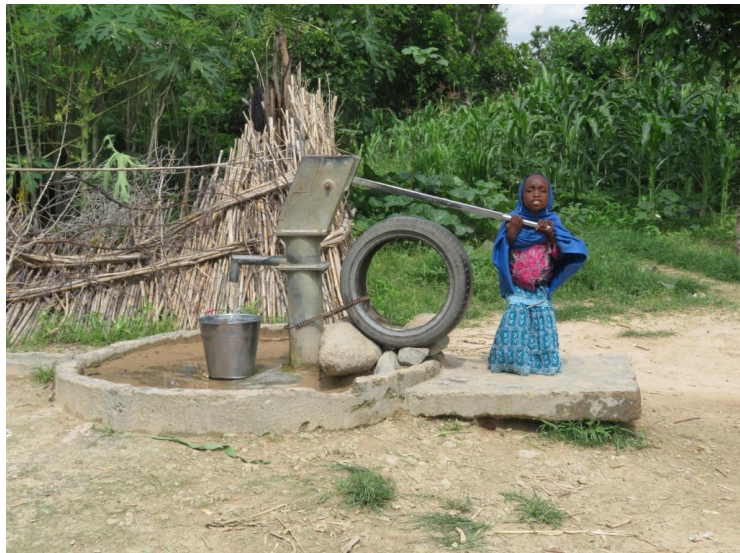
A girl using both her hands to get water from borehole constructed by using the drill procured by the project for her iron bucket, saving her time from going to distant pond to get water.

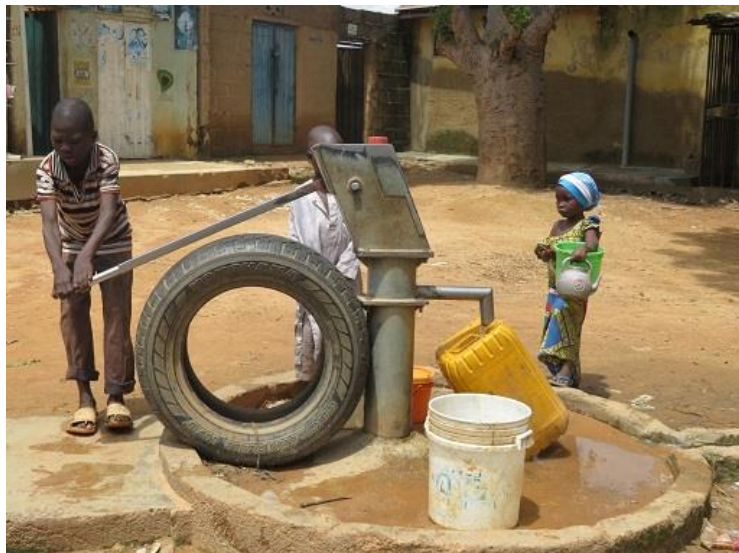
A boy tries to fill a 20 liter jerry can while two other kids await their turn at the borehole constructed by using the drill procured by the project.
