Country Name	<b>The Provision of Equipment for Rural Water Supply Project In the Central Dry Zone</b>
Republic of the Union of Myanmar

**I. Project Outline**

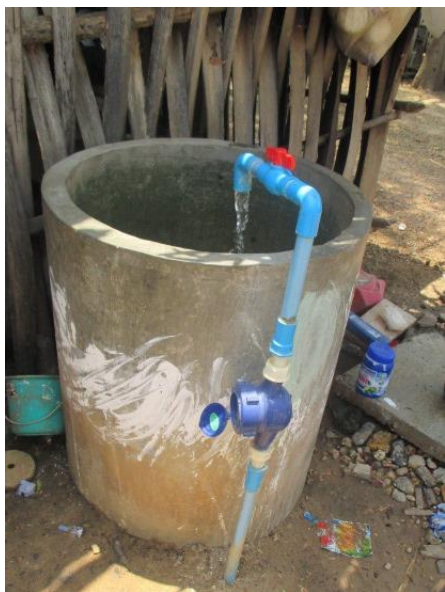
After completion of the project, a VWC by itself installed water distribution pipe from the tube well which was supported by JICA, so that every household in the village can draw water in their house (Magway Region).

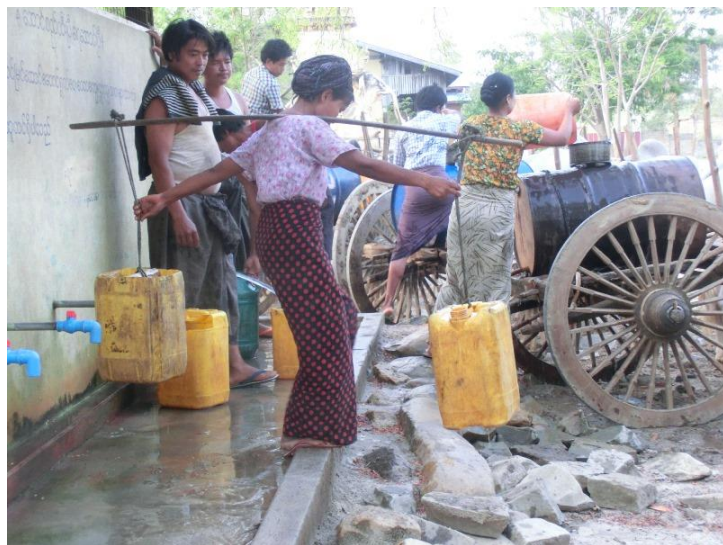
It was observed that, in the evening time, many village people come to the tube well to fetch the water. According to the village people, time to fetch the water was reduced from 40-60 minutes to only 15 minutes on average (Mandalay Region).
