Internal Ex-Post Evaluation for Technical Cooperation Project and Grant-Aid Project combined

conducted by Democratic Republic of Congo Office: February 2020

Country Name	Technical Cooperation Project (TC): Project on Capacity Development for Bridge Management
Democratic Republic of the Congo	Grant-Aid Project (GA): Project of Improvement of the Marshal Bridge in Matadi

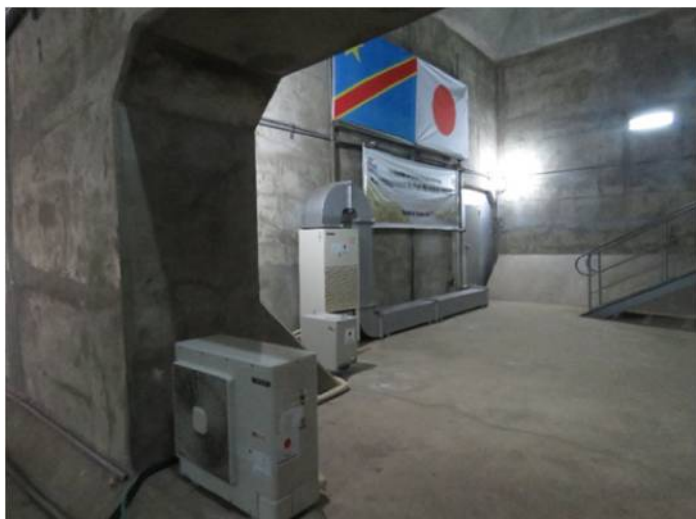
Injection dry air system machine (GA)

The quantitative effects have manifested by the time of ex-post evaluation. Both the humidity inside the main cable (Indicator 1) and the traffic volume (Indicator 2) of the Matadi Bridge achieved the target. The humidity significantly decreased from more than 75% to below 50% thanks to the dry air injection system together with the new substation installed by the Congolese government under this project, which has enabled continuous operation of the machines.

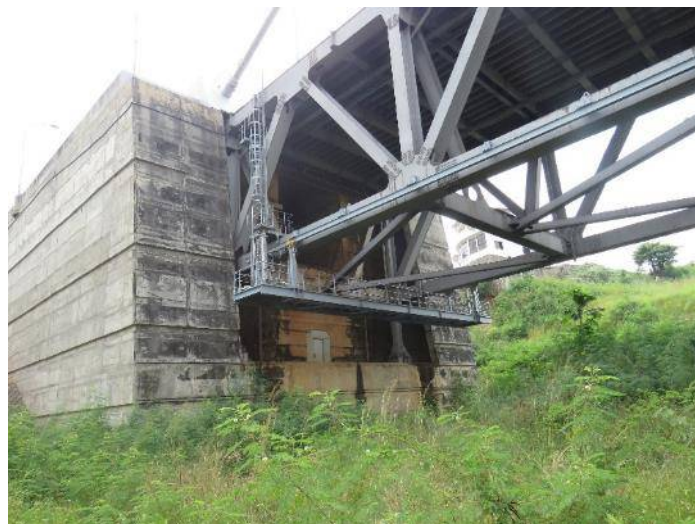
Inspection trolley (TC)

<table><tr> <td style="width: 50%;">Japanese Side</td> <td style="width: 50%;">DRC Side</td> </tr><tr> <td>3) Equipment: inspection and repair equipment (high-place work benches, inspection trolleys, tower inspection elevators and elevator driving units, construction machinery such as rolling machine, etc.)</td> <td></td> </tr></table>
