Country Name	Project for Landslide Management
Republic of Mauritius

I. Project Outline

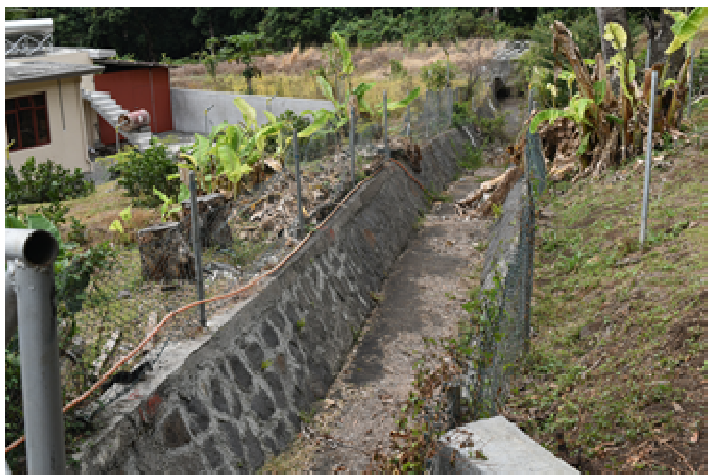
Countermeasure works at Chitrakoot were duly implemented and preventing danger to local inhabitants.

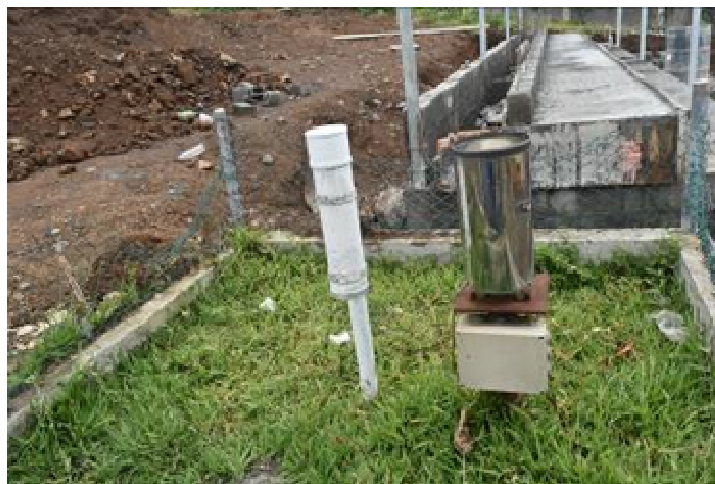
Rain gauge at Quatres Soeurs, installed by Mauritius Meteorological Services as a complementary tool for the MPI's monitoring system
