FY2019 Ex-Post Evaluation of Japanese Grant Aid Project

“The Project for Construction of Bridges in the Province of Nusa Tenggara Barat”

“The Project for Construction of Bridges in the Province of Nusa Tenggara Barat, Phase II”

“The Project for Construction of Bridges in the Province of Nusa Tenggara Barat, Phase III”

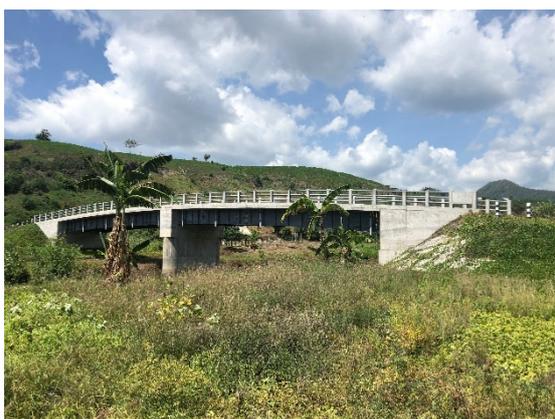
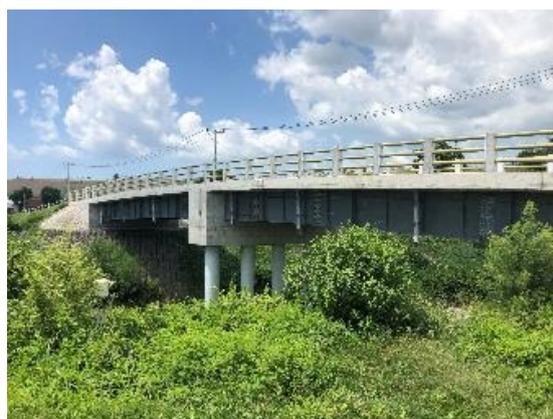
Project Bridges (Left: Lamar Bridge; Right: Emang Bridge )

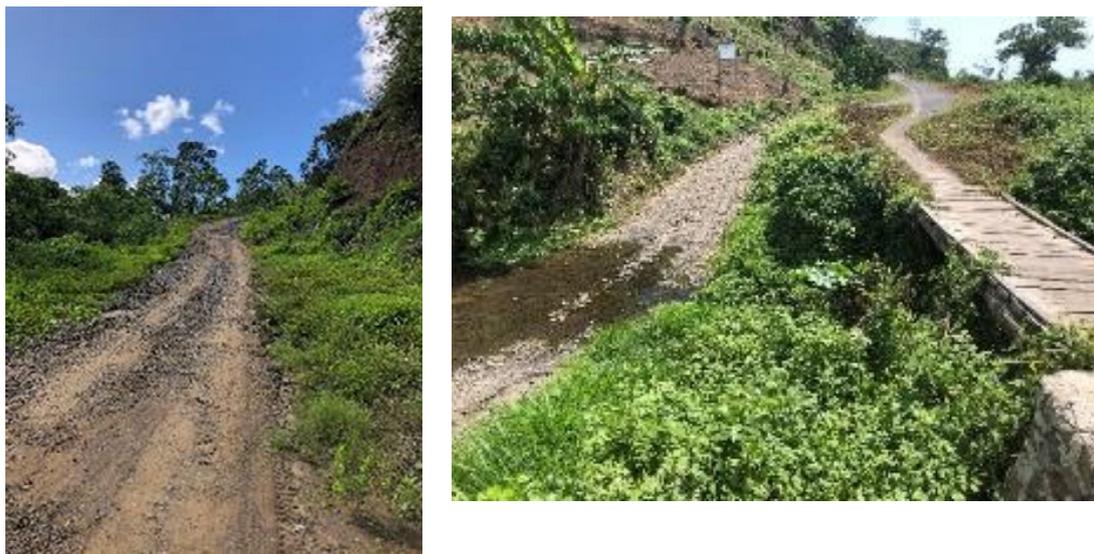
On the other hand, some of the construction works by the Indonesian side are yet to be completed at the time of the ex-post evaluation. During the field study, we have confirmed that the pavement of roads and construction of small bridges, which should be borne by NTB, have generally been completed, but there are still some unpaved roads and temporary bridges in the Phase II and III sectors. In detail, there are one unpaved section between Negene and Tatar Loka bridges in the Phase II sector and another unpaved section near the end of the Phase II sector (on the Tatar side), and two sites in the Phase II sectors and three sites in the Phase III sector where permanent small bridges are to be constructed. According to NTB, to complete a construction at these sites, tenders for the construction are to open in 2020 and the construction work is expected to be completed in 2022. With regard to land acquisition by Sumbawa Regency and West Sumbawa Regency, we have been unable to obtain direct

Unpaved Sector and Small Bridge Construction Site

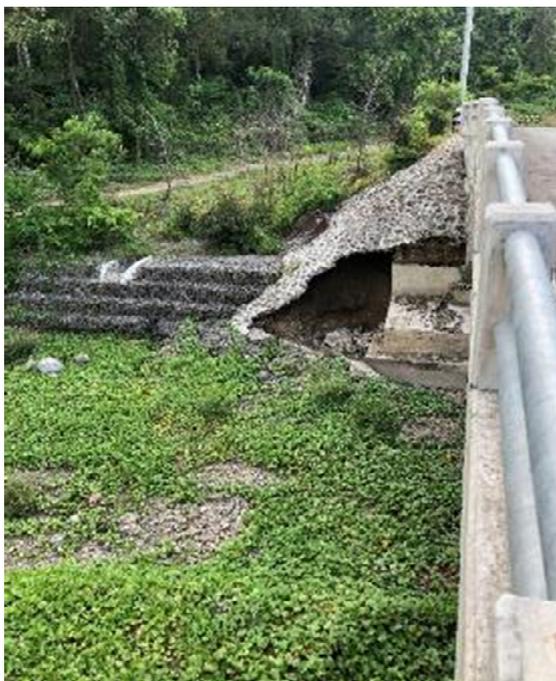
Through interviews with the Technical Road Planning Section, we have heard that no major problems had happened in the project bridges by the time of the ex-post evaluation, and accordingly, there were no plans to repair the bridges. In contrast, we have checked the condition of each project bridge through the field study and found abutment protections

collapsed and road surface deteriorated in some of the bridges. We then asked back the Technical Road Planning Section about these matters, and they answered that they had not been aware of the problems but would carry out repair works on the said bridges within the scope of the FY2020 budget. One of the reasons for their overlooking could be attributed to a lack of bridge inspection/assessment manual. The criteria for assessing the condition of bridges and the items to be inspected are not clearly defined, so even if a bridge was in a condition that an inspector should report as “repairs required,” it might have been overlooked by the inspector due to his/her subjective judgment. Additionally, inspection results are not necessarily recorded on paper or electronic media, suggesting there is a need for improving the way of information management. The Technical Road Planning Section is also aware of the need to develop the bridge inspection/assessment manual and seeks a support for establishing such manual.

Collapsed Abutment Protection (Mone I)

As for the maintenance of bridges, criteria for assessing conditions of the bridges and items to be inspected are not clearly defined and are largely left to the subjectivity of individual inspectors. As a result, bridges in a condition that the inspector should report as “repairs required” may be overlooked due to his/her subjective judgment. Therefore, NTB should establish a bridge inspection/assessment manual and have objective criteria for the assessment, and then conduct such inspections/assessments. It is also important to secure every year a budget for the maintenance of roads and bridges so as to ensure that the inspections and repairs are carried out steadily.

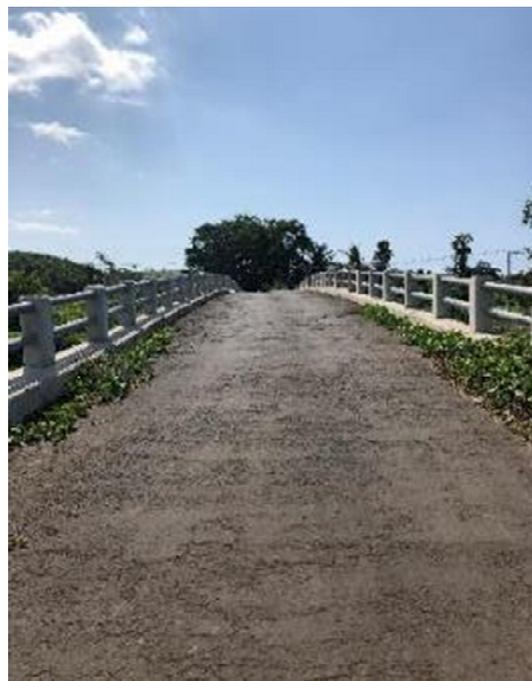
Deteriorated Road Surface (Telonang I)

project bridges by the time of the ex-post evaluation. The Implementation of Maintenance Section located in the Sumbawa Island cleans the bridges, briefly checks their conditions and reports to the Technical Road Planning Section if any problems are found. The frequency of inspection and cleaning was assumed to be once a year at the time of the project planning, so they are carried out as planned. On the other hand, repairs such as sealing of pavement cracks and patching of pavement pot holes were expected to be carried out twice a year at the time of the project planning, but they do not seem to be carried out as planned, judging from the deteriorated road surface of some bridges confirmed through the field study.
