Country Name	Landslide Disaster Management Project
Republic of Armenia

I. Project Outline

II. Result of the Evaluation

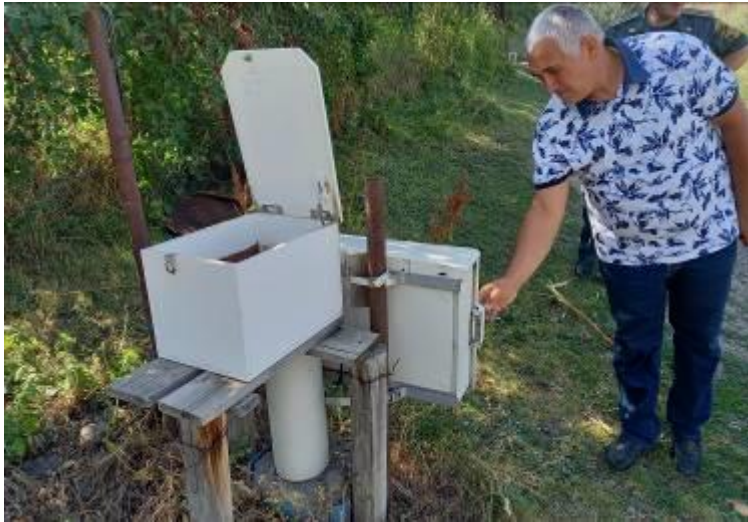
An MES engineer checking the operational status of landslide monitoring equipment provided by the project (in Arapi)

-It is recommended that MES find out appropriate information transfer cables that connect landslide measurement instrument with monitoring system at the pilot project sites in Getahobit and Voghjaberd and replace the damaged ones with them as soon as possible. Since MES cannot find it by themselves, support from Japanese side may be required.

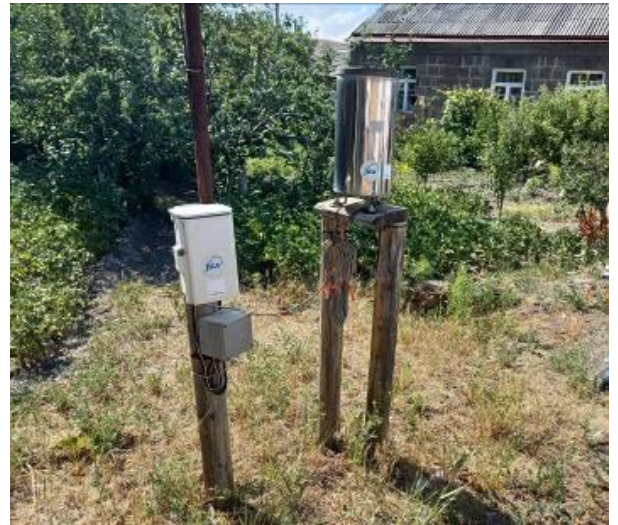
A set of tipping bucket rain gauge provided by the project also maintained in good condition (in Arapi)
