Country Name	The Project for Introduction of Clean Energy by Solar Electricity Generation System
Gabonese Republic

I. Project Outline

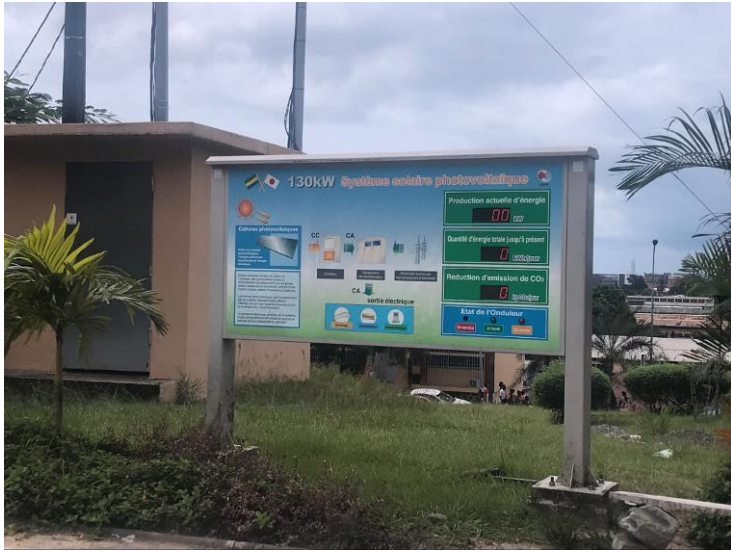
Bulletin board that displays the amount of electricity produced at UOB

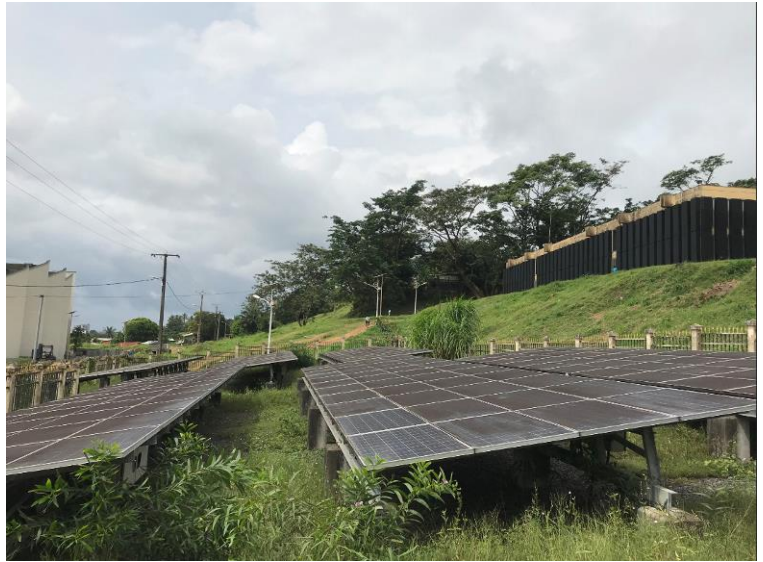
Most of the equipment items had been functioning well. However, the air conditioning system in the control room has been broken because a part of the system was stolen during the lockdown associated with Covid-19 in 2020. As a result, the facility cannot activate the inverters, and is not able to produce the electricity from the solar power system. In addition, the software installed on the PC in the room has malfunctioned, making it impossible to check the amount of electricity produced. As for the PV modules, 525 out of 572 modules installed at UOB (including modules moved from the MFAIC) have been functioning.

Solar panels installed at UOB

- It is recommended that Ministry of Energy and UOB increase security to prevent theft in the project site as it has occurred two times in 2018 and 2020 and some of project property has been lost.
- It is suggested that Ministry of Energy and UOB repair the air conditioning units installed to the control room so that the photovoltaic system can operate properly.
